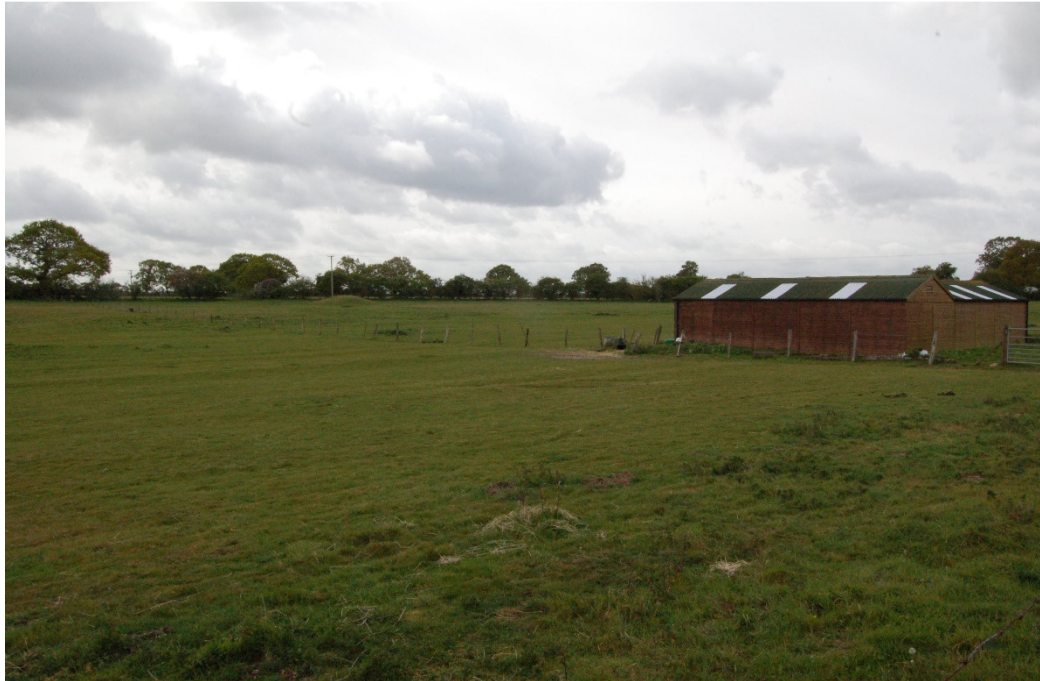
Figure 13-7 The southern part of the Roman Camp scheduled monument. Looking southwest, from the minor road that passes through the monument, towards the PEA which is not visible

Figure 13-9 View from outside the hedge on the northwest boundary of the PEA towards the southern part of the scheduled Roman camp, which is behind the full length of the hedge in the background. This hedge is visible in Figure 13-7 and in the foreground of Figure 13-8

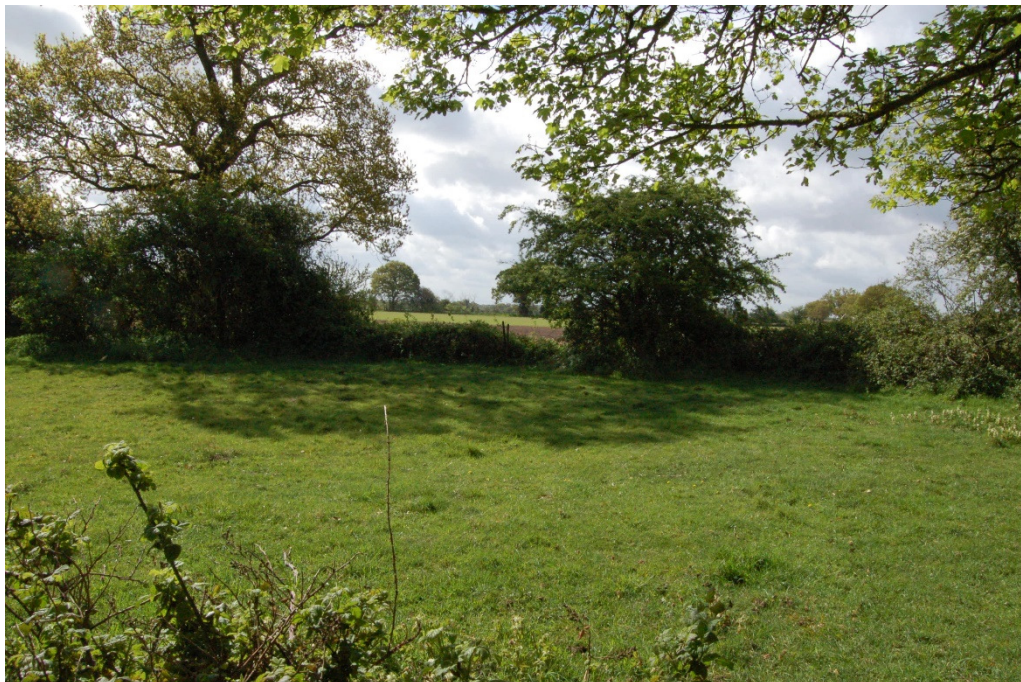
Figure 13-8 Looking south towards the northern part of the PEA from the southwestern corner of the southern part of the Roman Camp scheduled monument. The PEA is beyond the second/distant hedge and movement of machinery may be visible where there are gaps in both hedges

Figure 13-10 The hedge on the northern boundary of the PEA, looking east from the northwest corner of the PEA. Sections of this hedge are visible in the distance in Figure 13-8

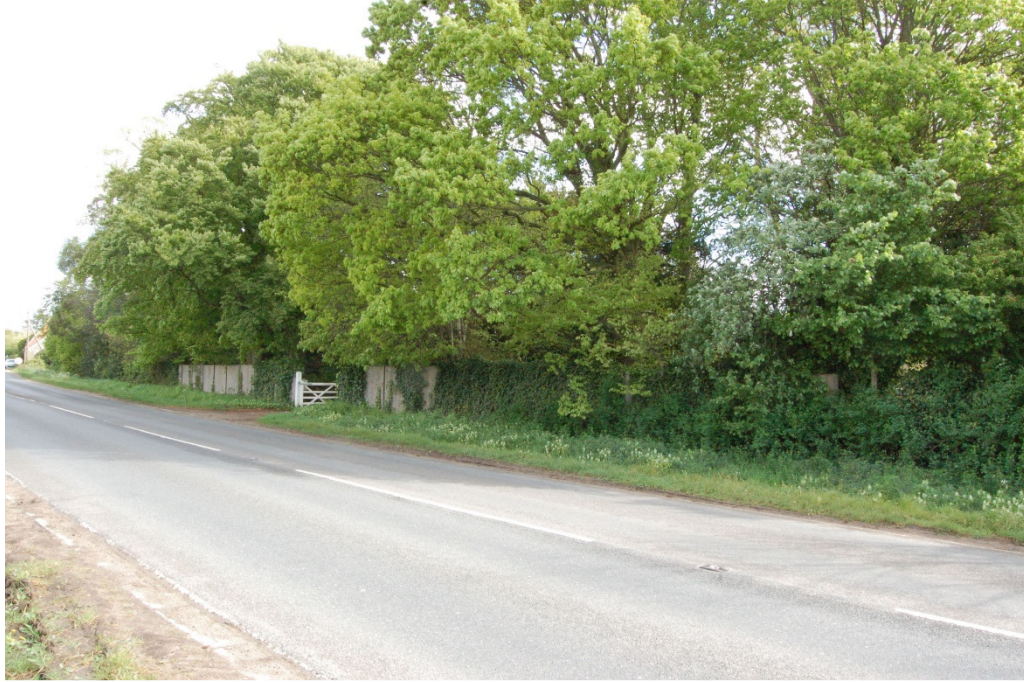
Figure 13-11 Tall well-established trees on the western edge of the curtilage of Horstead Lodge screening views to the PEA. The road shown is the B1150.

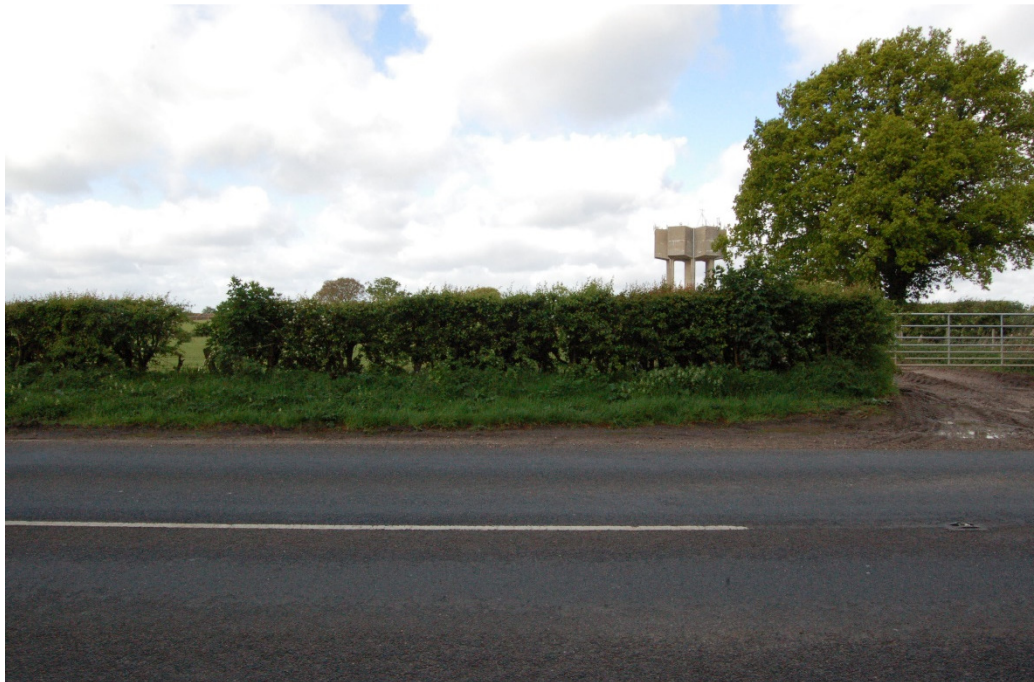
Figure 13-12 Looking westwards from where the entrance drive to Horstead Lodge meets the B1150. The PEA is in the distance, beyond the grass field concealed by the hedge.

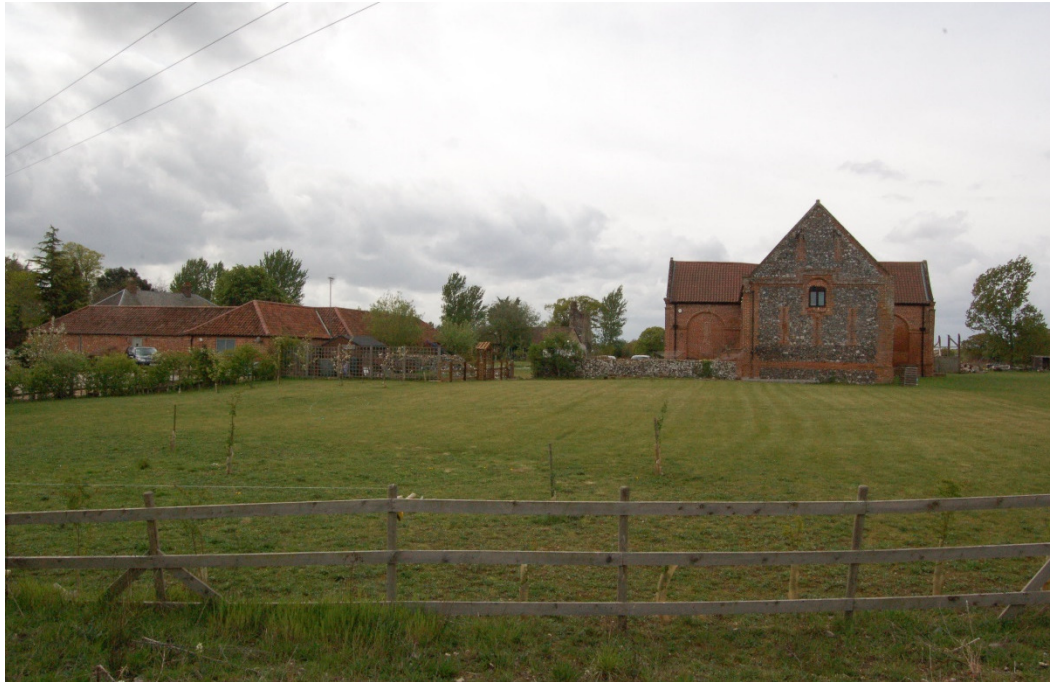
Figure 13-13 Looking west southwest at Stanninghall Farm Barn (right), from a track to the northeast. Other farm buildings and the roof of Stanninghall Farm House are on the left.

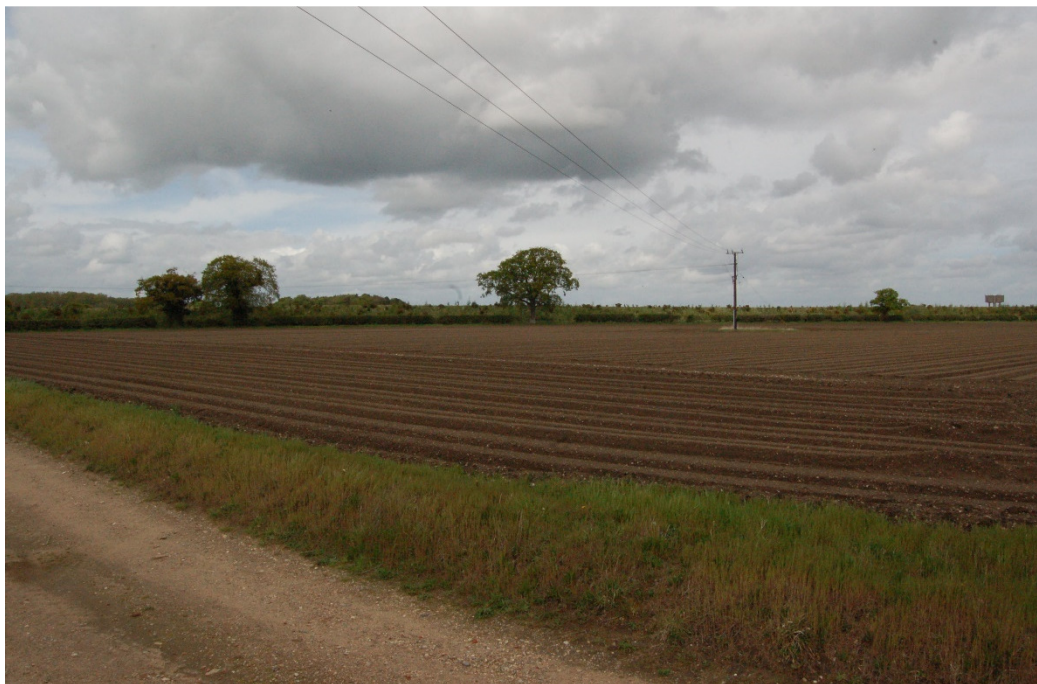
Figure 13-14 Looking northeast from a track to the northeast of Stanninghall Barn, towards the existing quarry. The grass and planted bund on the southwest of the existing quarry is visible centre background across the width of the photograph but merges well into landscape

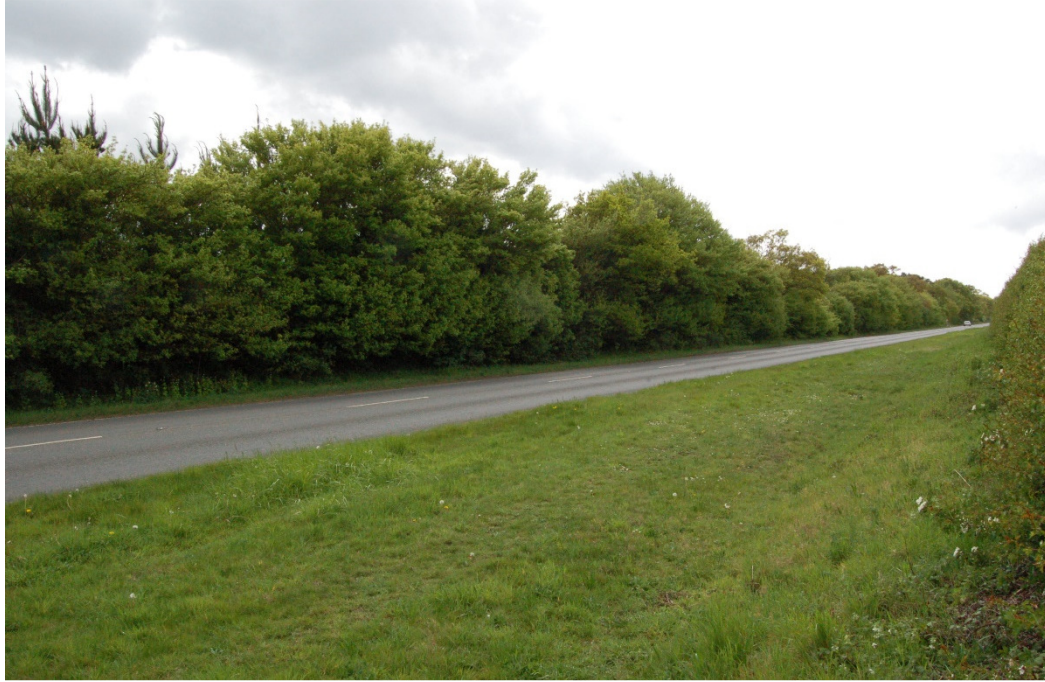
Figure 13-15 Tree belt (left) and hedge (right) beside the B1150, both of which block views from the PEA (not visible, to the right of the hedge) towards Heggatt Hall.

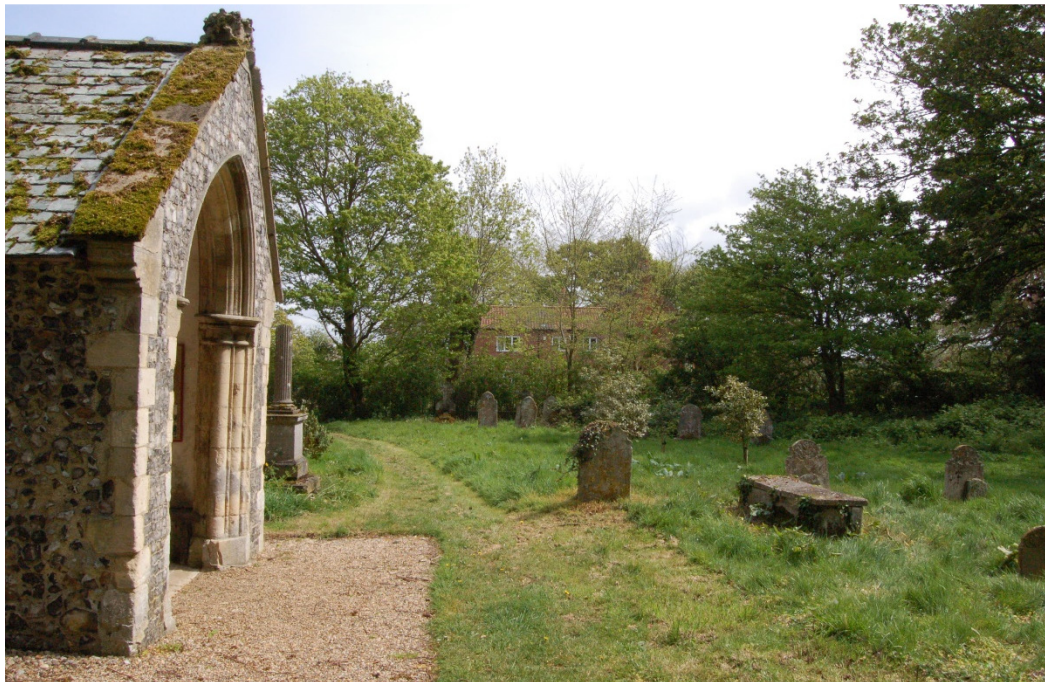
Figure 13-16 Looking east towards the PEA (not visible), from ground level, next to the south porch at the Church of St Swithin, Frettenham. Glebe Farm House is visible through the trees.

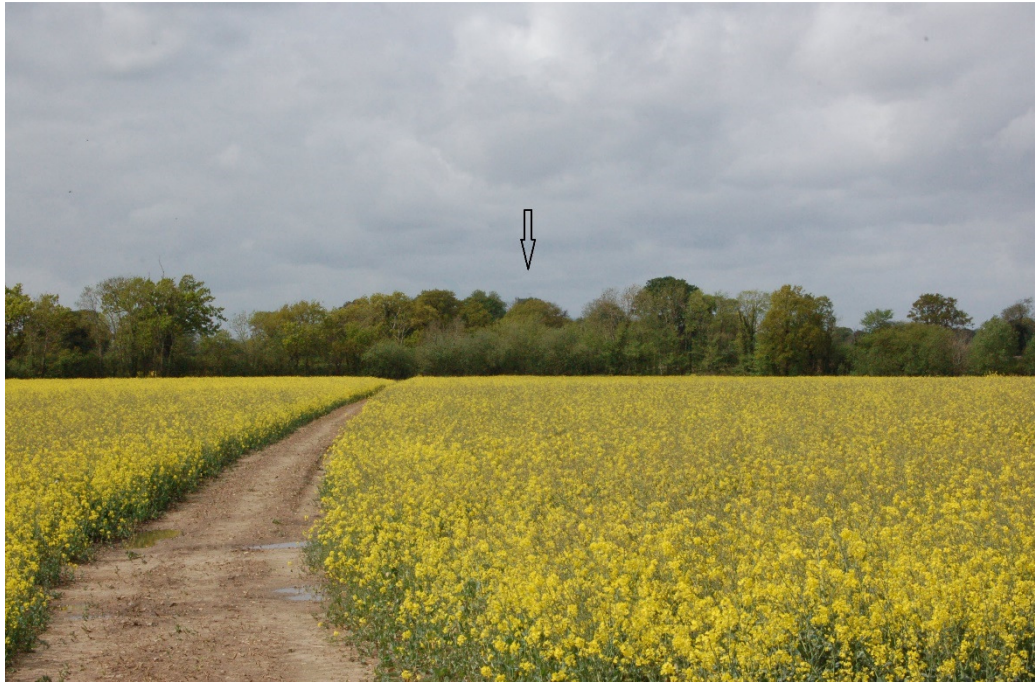
Figure 13-17 View from the road on the western side of the PEA, looking west along a footpath towards the Church of St Swithin, Frettenham. The top of the church tower is just visible above the top of trees (marked with an arrow).

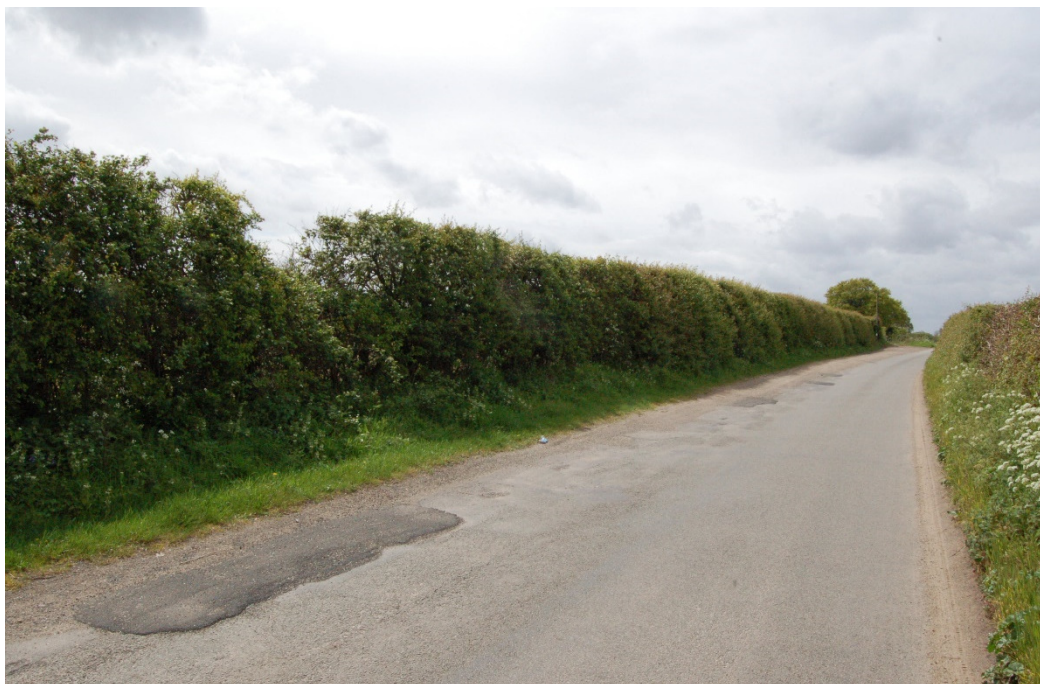
Figure 13-18 Existing tall hedge on the western side of the PEA, looking southwest along the road on western side of PEA. The hedge is 3-4m tall and blocks views from the PEA towards the Church of St Swithin.

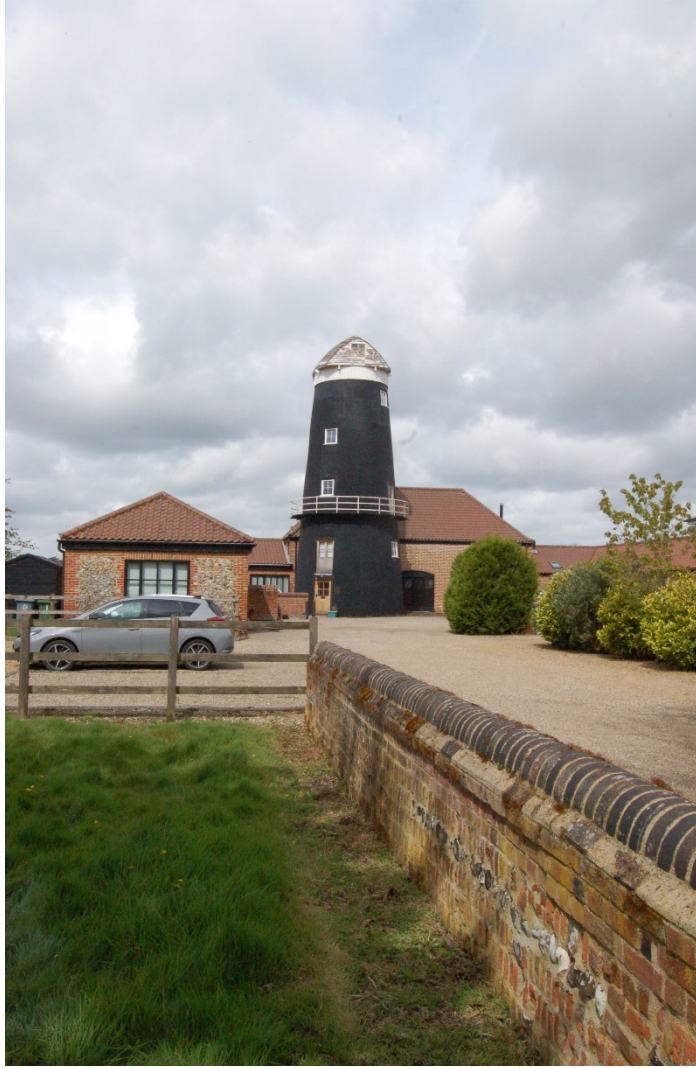
Figure 13-19 Frettenham Cornmill, from the southeast. The fourth-floor (uppermost) window has a view of the current quarry and may have an oblique, long-distance views of the PEA, although largely blocked by Clamp Wood.

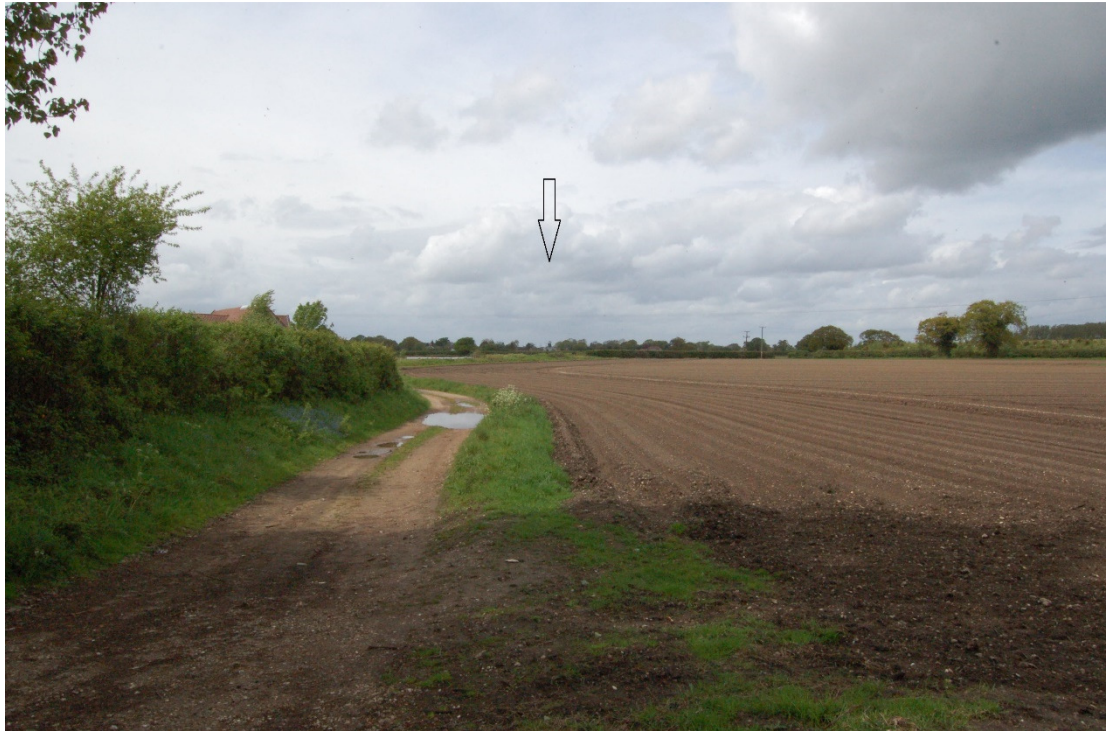
Figure 13-20 The tower of Frettenham Cornmill, from the east southeast at Stanninghall Street (arrowed). The grass and planted bund on the southwest of the current quarry is visible centre right.
