ULTIGRIP

A623 SPARROWPIT, NEAR BUXTON

Case Study Update

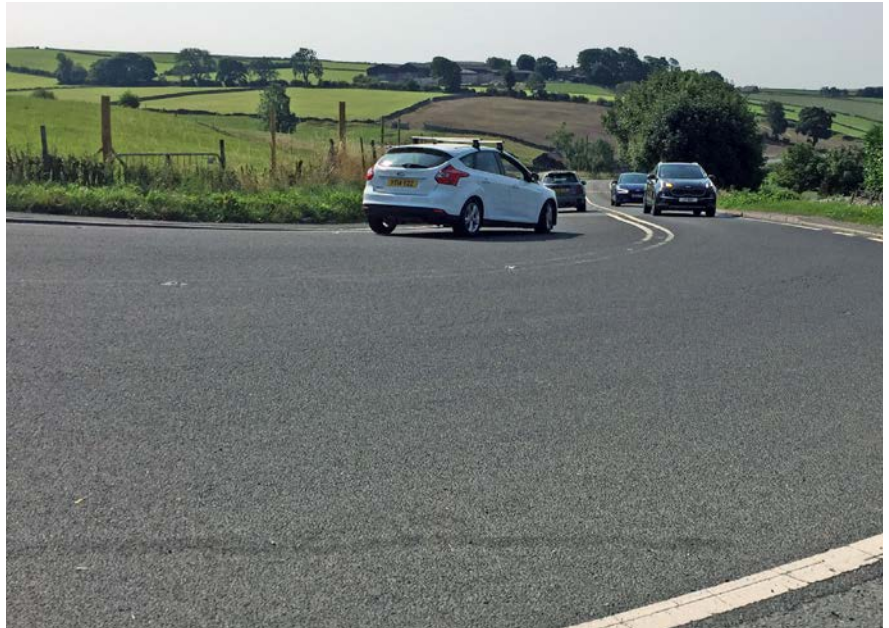
This section of road was visited again in August 2022, over four years after the work was completed. Apart from some noticeable oil stains, the road surface was in extremely good condition with no visible cracks or fretting. This is particularly impressive considering that the surface is subjected to heavy loading on the tight bends in the road. It demonstrates the lasting durability of Ultigrip.

As planned, the old surface was planed out to a depth of 100mm and 60mm of AC 20 DBC was laid, followed by 40mm of ULTIGRIP. Around 110 tonnes of ULTIGRIP was used in a dark grey colour. Both layers were completed in a single night, with minimal disruption to road users. Traditional high friction surfaces typically need to be replaced every 2-3 years. Given the history of this site this would mean frequent replacement. ULTIGRIP has a proven record of performance including at the very first site on the A6 near Rowley which is now 20 years old. It has been typically shown to last up to three times longer than HFS, meaning expected savings in whole life cost and reduced future road closures.
