ULTILAYER SAMI

Crack resisting concrete overlay system

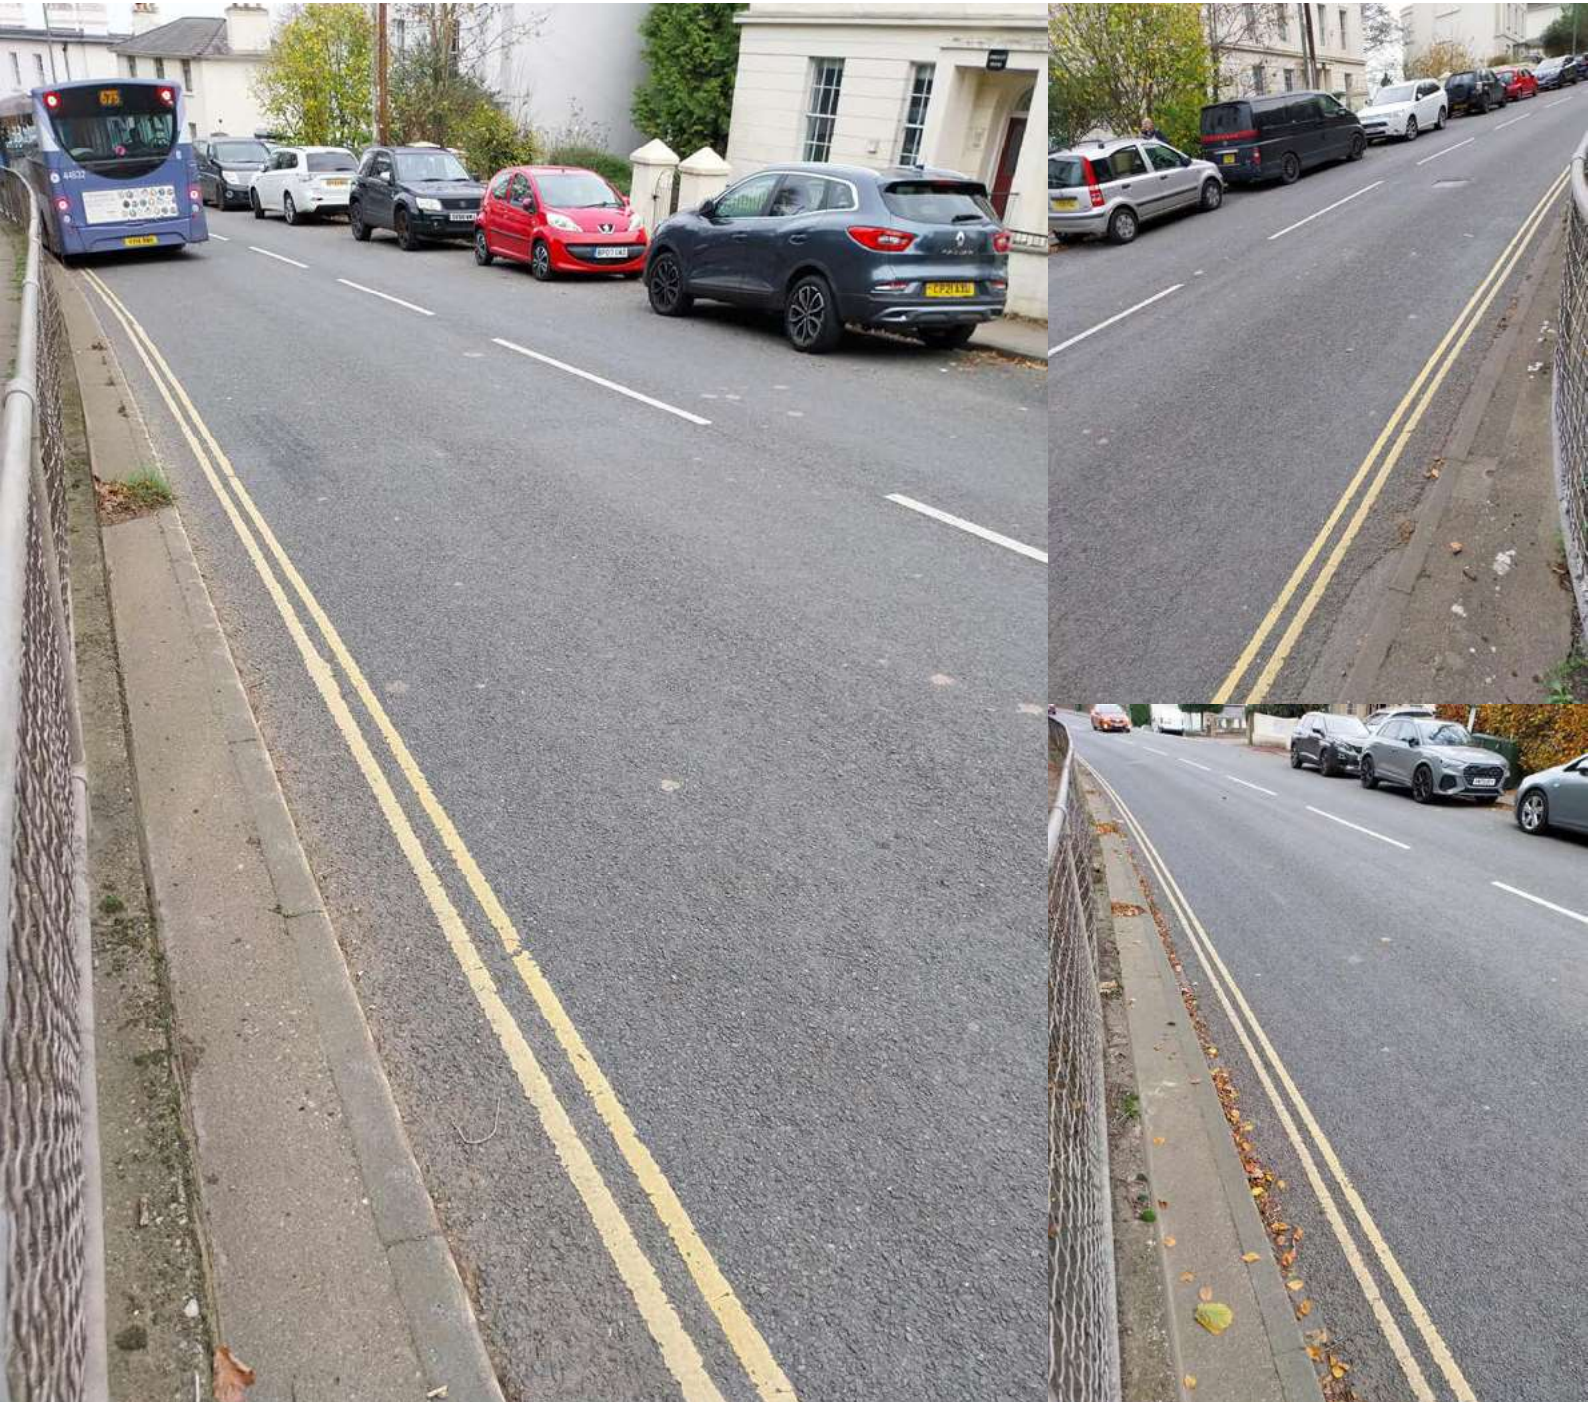
The crack resisting SAMI and ULTILAYER surface course is still performing well on this challenging section of road and is still crack free, despite frequent HGV and bus traffic and visible cracking on the adjoining hot rolled asphalt (HRA) surface.

The concrete was then overlaid with 25mm ULTILAYER SAMI followed by 40mm of ULTILAYER 10mm surface course.
